**SURE FOUNDATION**  
HOME INSPECTION

## YOUR HAPPY INSPECTORS REPORT

del city, OK 73115

09/20/2025

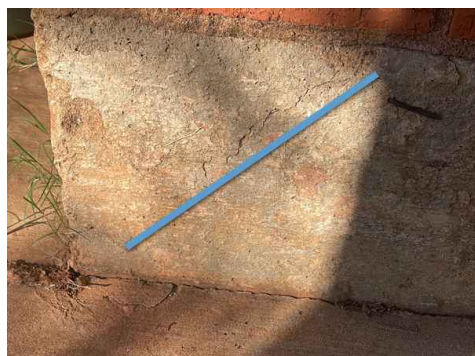
South West Wall

A corner pop was observed on the foundation. This condition can indicate stress on the foundation and may result in further structural distress over time. It is recommended that a qualified foundation expert be consulted to further evaluate and provide recommendations for any necessary repairs.

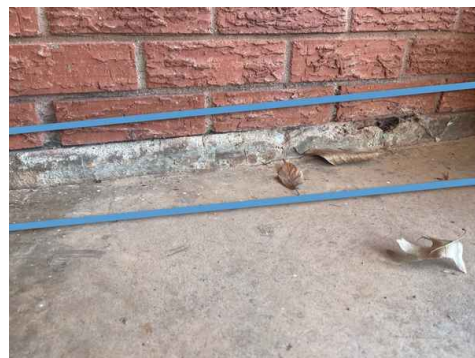
**HONEY COMBING ON FOUNDATION**

During the inspection. It was noted areas of honeycombing on the foundation wall, which looked like rough, Rockfield holes. this happens when the concrete mix did not fully fill the space, leaving gaps in the material. These spots are weaker than the rest of the wall and can let in water, which is not what is recommended for a good barrier,. Preparing these boys is recommended to make the wall stronger and ensure the foundation remains up to acceptable standards.

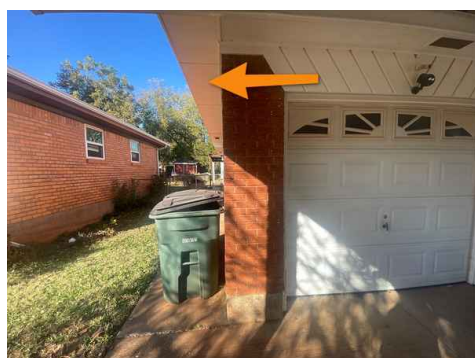
North West Wall

**MINOR WALL MOVEMENT**

Wall movement indicates slight shifts or settlement in the structural framework. During inspection, minor displacement was observed, which could potentially signal underlying foundation or framing issues. While not immediately critical, continued monitoring is recommended to prevent potential structural complications.

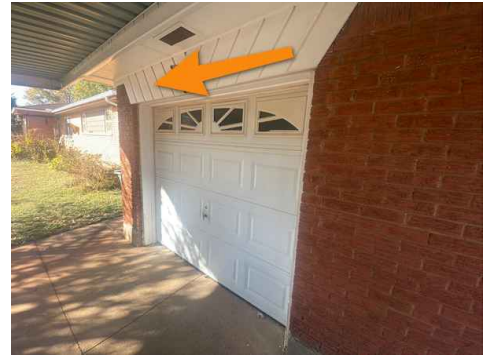
**GARAGE HEADER MOVEMENT**

Noted garage door header sagging, twisted or uneven. Recommend evaluation and repair by qualified professional.

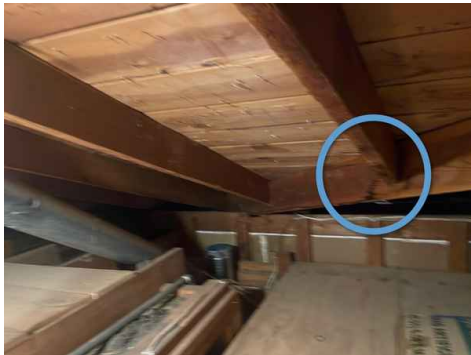
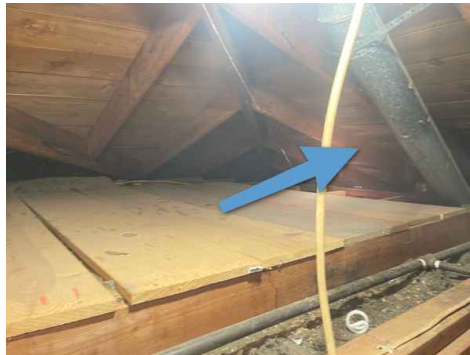
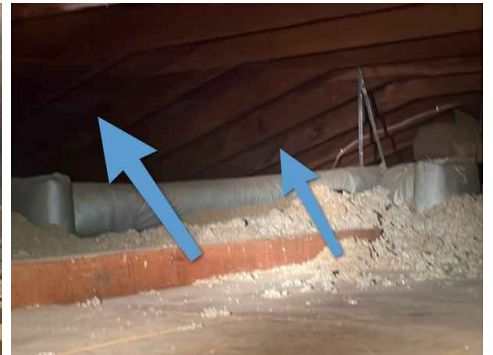
**EVIDENCE OF WATER INTRUSION**

Ceiling structure showed signs of water intrusion, which could lead to more serious structural damage. Recommend a qualified contractor identify source or moisture and remedy.

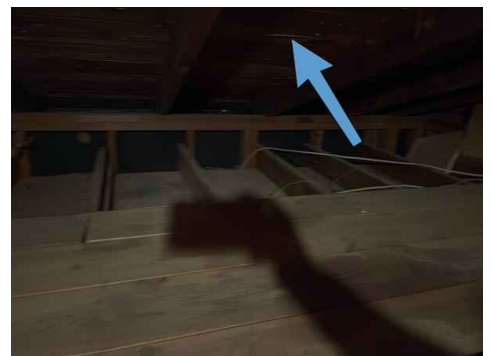
**GAPS IN SLAT DECKING**

Gaps are noted in the slot deck going to be over 1/8 inch, this prevents proper nailing and support of shingles. This can allow wind and water damage to occur easier. Recommend evaluation by qualified roofer.

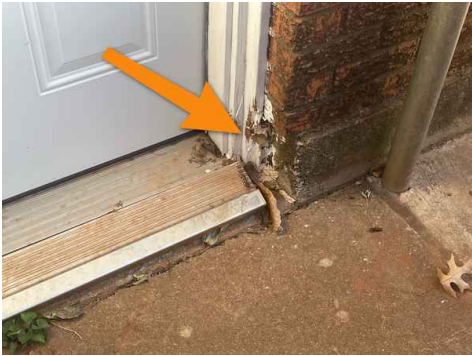
Wall East

### **DOOR WOOD DECAY OBSERVED**

Observed wood decay on the exterior door and/or trim. Further evaluation or correction is recommended.

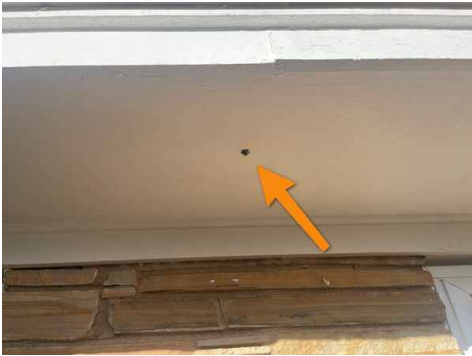
North Wall

HOLE IN EXTERIOR

Observed hole in exterior siding, this can let in moisture and pest intrusions. Recommend sealing DIY or Handyman

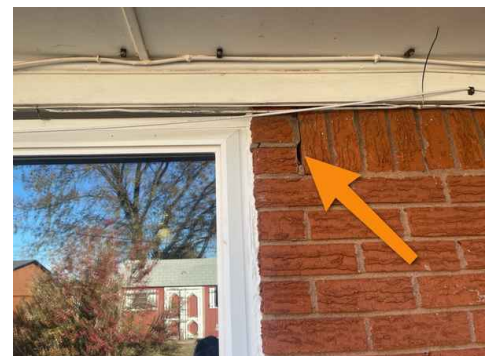
North Wall

##### **MASONRY CRACKS MODERATE**

Moderate exterior wall cracks discovered during inspection. These cracks indicate potential settlement. Recommend professional evaluation to assess underlying causes and potential repair strategies.

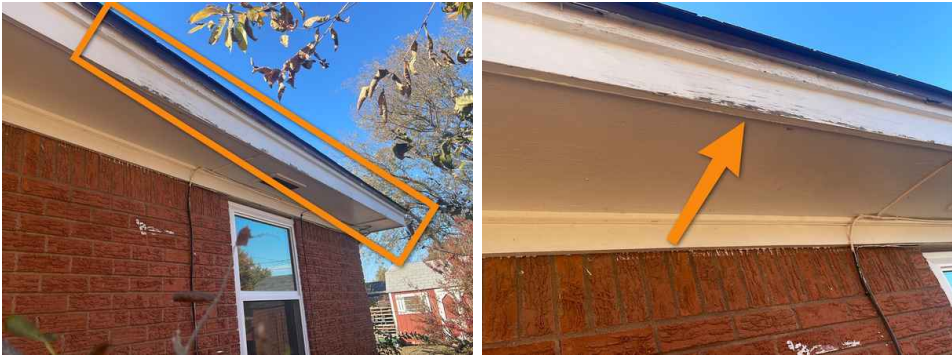
##### **EXTERIOR PAINT FAILING**

I observed indications of paint or staining in poor condition. Flaking, cracking, and worn areas. Correction and further evaluation is recommended.

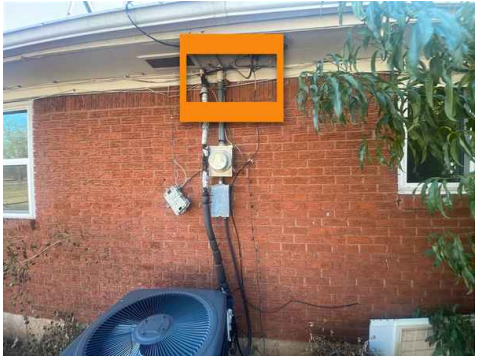
North Wall

**SOFFIT DAMAGE OBSERVED**

I observed indications that one or more areas of the soffit were damaged.

Correction and further evaluation is recommended.

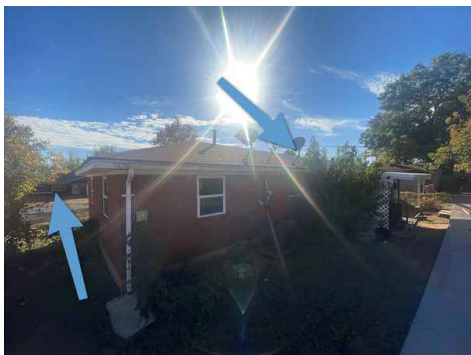
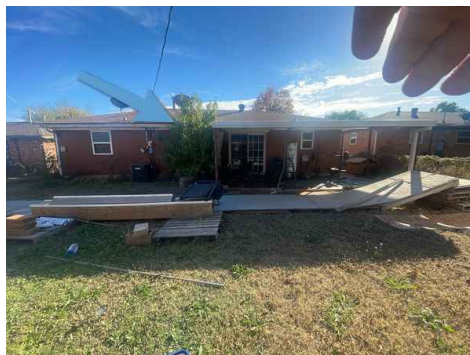
I observed indications that a tree and or tree branch were overhanging the roof and maybe in contact with it.

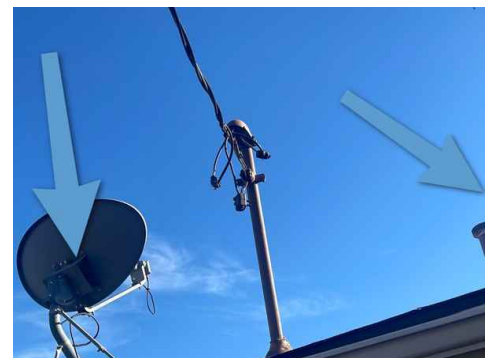
North Slope

#### SATELLITE DISH INSTALLED

It was observed that satellite dishes were attached directly to the main roof. The mounting hardware creates potential penetrations through the roofing material; this is not recommended. Removing the satellite dishes and sealing the holes is recommended.

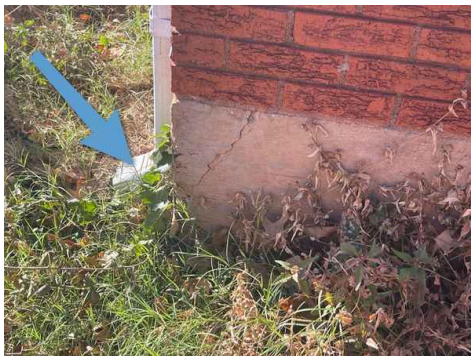
North East Yard

One or more downspouts drain too close to the home's foundation. This can result in excessive moisture in the soil at the foundation, which can lead to foundation/structural movement. Recommend a qualified contractor adjust downspout extensions to drain at least 6 feet from the foundation. A handy homeowner should be able to do this project.

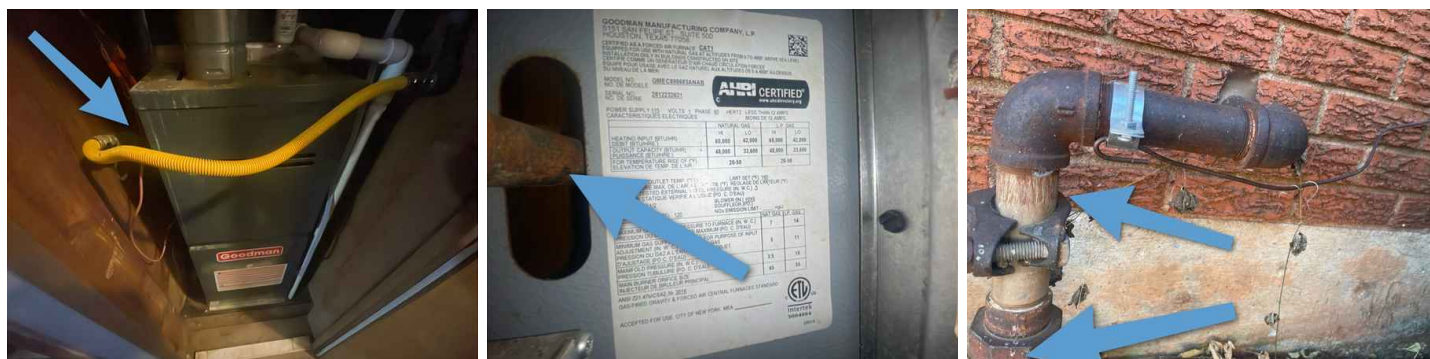
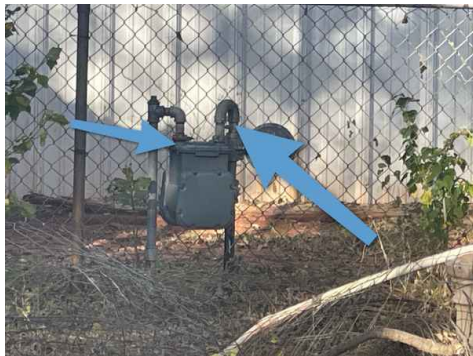
Noted during inspection, gas lines have spots in areas of rest, recommend monitoring

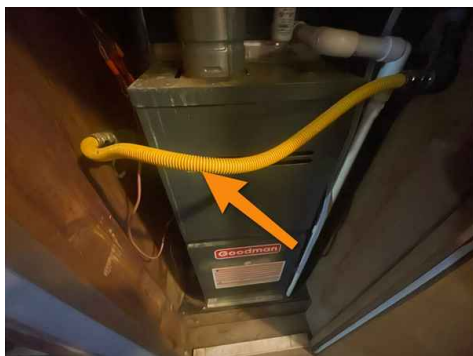
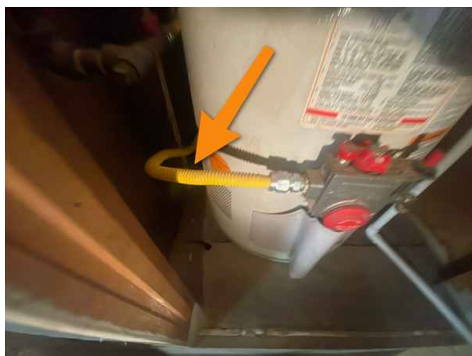
#### CSST NOTED

The inspector shall note the presence of any shade of yellow corrugated stainless steel tubing ("CSST") flexible gas piping observed during the inspection in which the inspector is not required to identify concealed conditions, components not readily accessible, or any other item excepted from inspection pursuant to OAC 158:70-1-3. If any shade of yellow CSST flexible gas piping is observed, the home inspector shall notify the client, in writing, as follows: "Manufacturers believe the product is safer if properly bonded and grounded as required by the manufacturer's installation instructions. Proper bonding and grounding of the product can only be determined by a licensed electrical contractor."

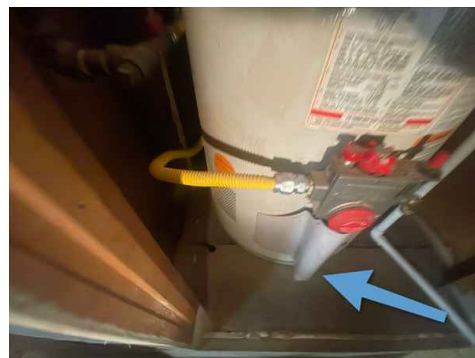
#### MISSING CATCH PAN UNDER TANK

I observed that the hot water tank is missing a water leak catch pan.

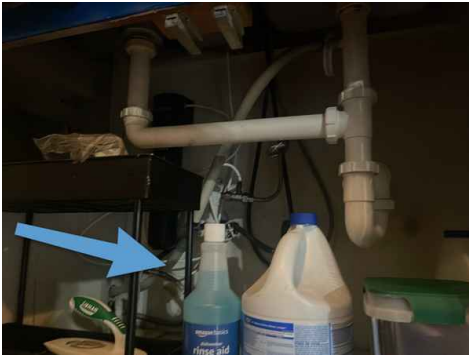
Recommend upgrading discharge line to have a high loop to create a air gap so the dishwasher doesn't siphon dirty water.

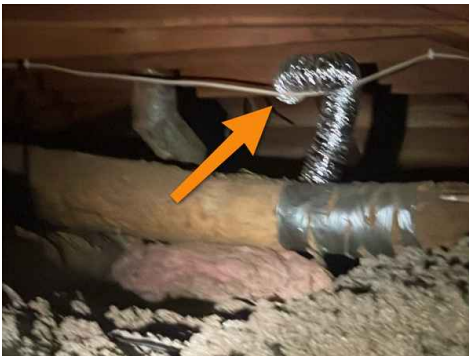
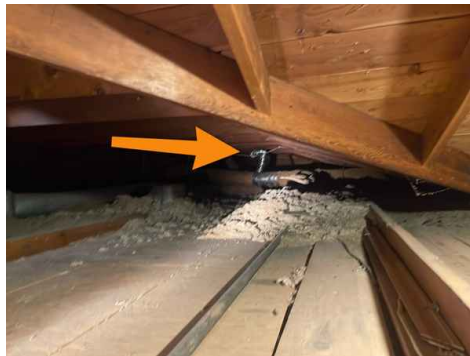
I observed that the exhaust fan terminates into the attic. This can result in moisture damage and mold in the attic.

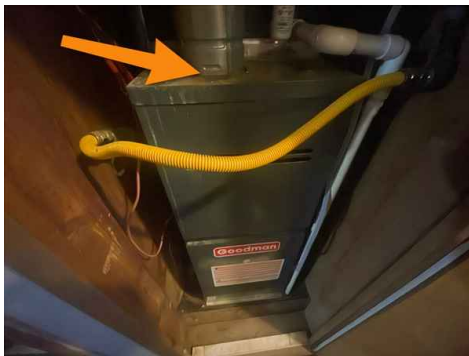
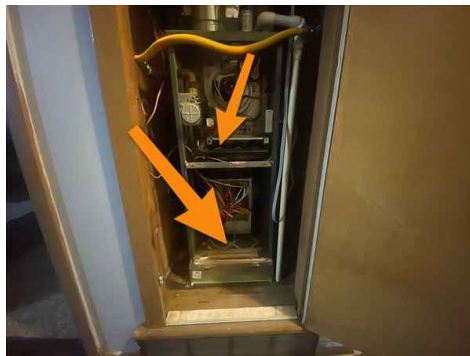
**CORROSION & RUST**

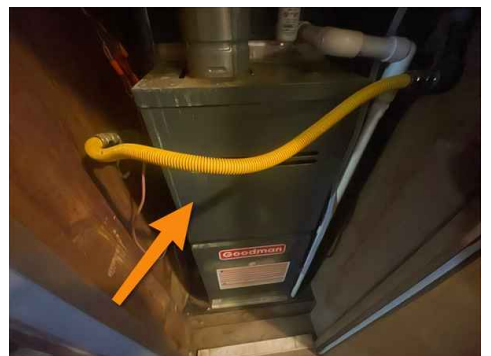
Observed CSST (corrugated stainless steel tubing) at the furnace. Though it's fairly common the presence of any shade of yellow corrugated stainless steel tubing ("CSST") flexible gas piping observed during the inspection in which the inspector is not required to identify concealed conditions, components not readily accessible, or any other item excepted from inspection pursuant to OAC 158:70-1-3. If any shade of yellow CSST flexible gas piping is observed, the home inspector shall notify the client, in writing, as follows: "Manufacturers believe the product is safer if properly bonded and grounded as required by the manufacturer's installation instructions. Proper bonding and grounding of the product can only be determined by a licensed electrical contractor." This is your writing.

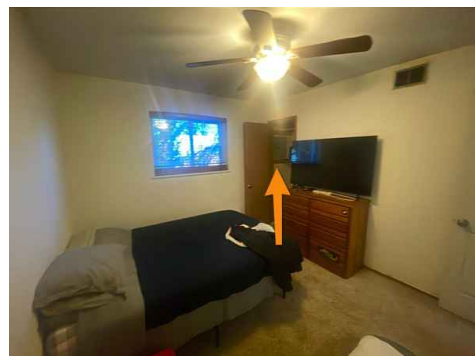
East Bedroom Closet

I observed that the electrical panelboard was located inside a clothes closet, and for your safety I would recommend saving and planning to get it installed either in the garage or on the exterior of the wall.

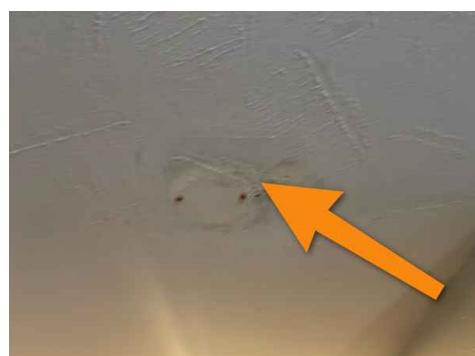
Hallway

I observed indications of a missing smoke detector. Hazard.

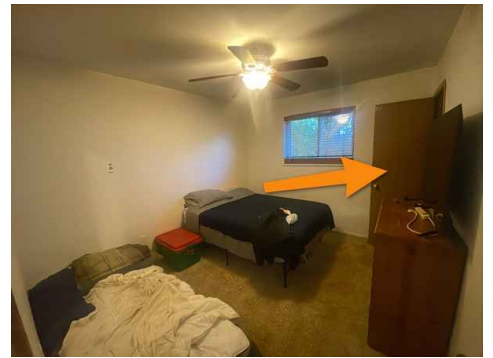
East Bedroom Closet Door

Observed closet door that has access to electrical panel sticks and is not easy to open. Not a major safety risk but due to the fact that the electrical panel is in that closet I would recommend DIY or qualified handyman to replace door for ease of opening.

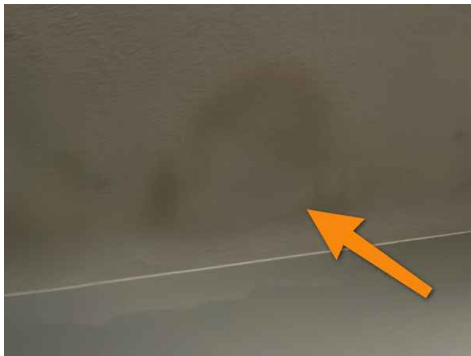
East Bedroom

There is a stain on ceiling/wall that requires repair and paint. Source of staining should be determined.

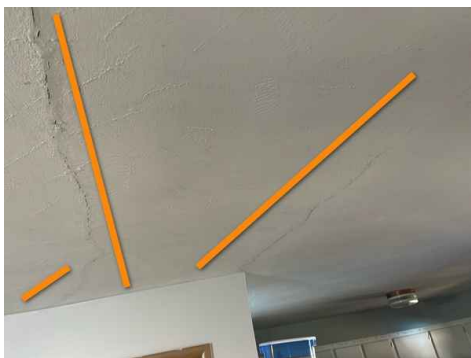
Living Room, Dining Room

Moderate Deficiencies**CEILING CRACKS**

Observed cracks and ceiling. Cracks are fairly good size, but there's no indication of structural damage recommend monitoring.

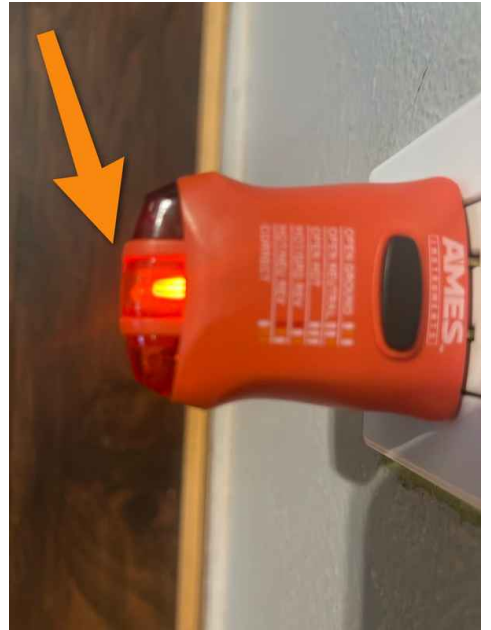
North Wall Hallway

**MISSING GROUND AT RECEPTACLE**

I observed indications of a missing, open, or disconnected ground at a receptacle. Hazard.

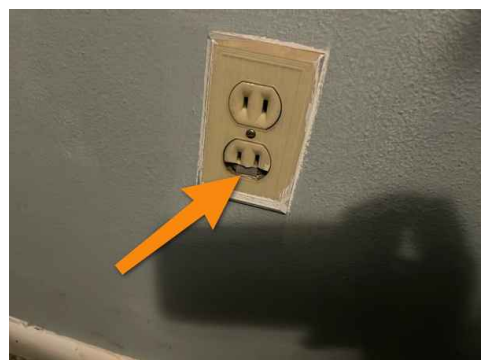
East Wall Primary Bedroom

**DAMAGED ELECTRICAL COMPONENT**

I observed damage to an electrical component. Electrical hazard.

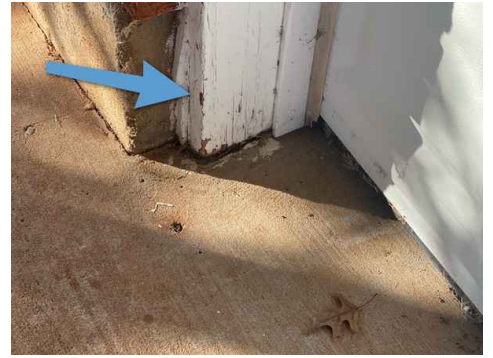
**WEATHERED CONDITION AT GARAGE DOOR**

I observed weathered conditions at the garage door. Indications of delayed maintenance.

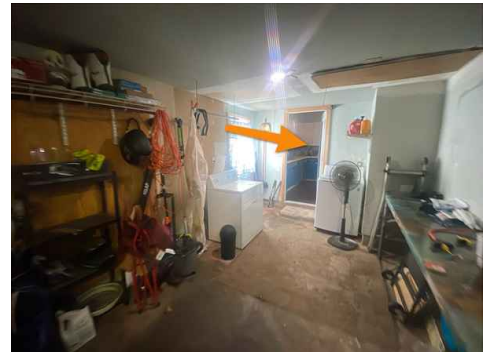
**DOOR WAS NOT SELF-CLOSING**

I observed that the door between the garage and the house is not equipped with a self-closing or an automatic-closing device. This is a fire hazard.

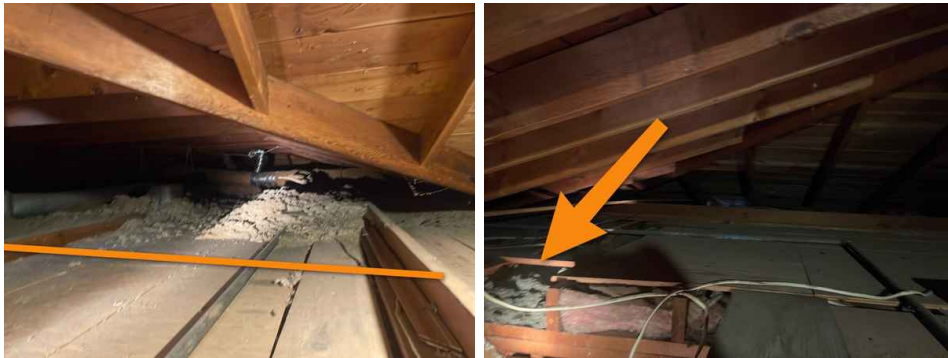
I observed indications of the general absence of insulation in the unfinished attic area.

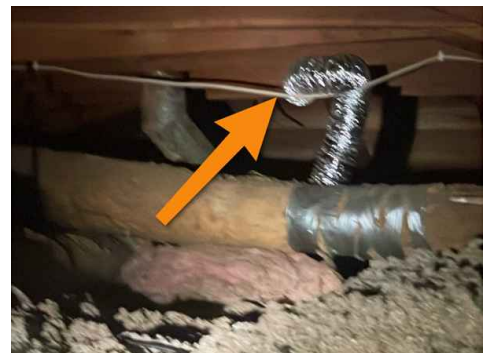
#### **IMPROPERLY EXHAUSTING**

Exhaust air from bathrooms, toilet rooms, water closet compartments, and other similar rooms shall not be:

- exhausted into an attic, soffit, ridge vent, crawlspace, or other areas inside the building; or
- recirculated within a residence or to another dwelling unit.

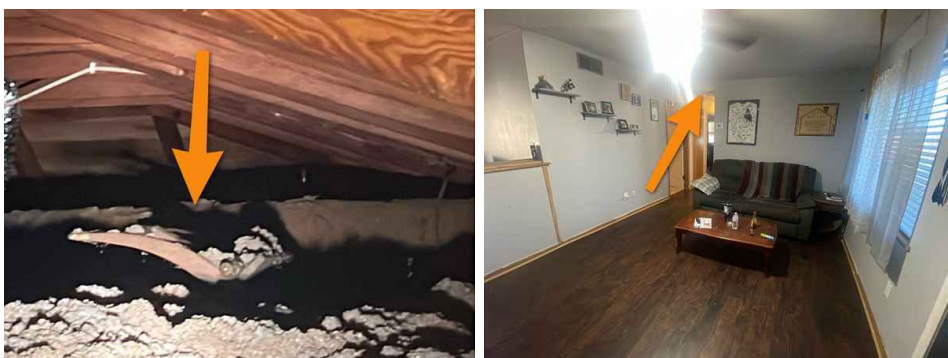
#### **WHOLE HOUSE FAN INOPERABLE**

Whole house fan was inoperable at time of inspection. Recommend a qualified whole house fan contractor evaluate and repair.

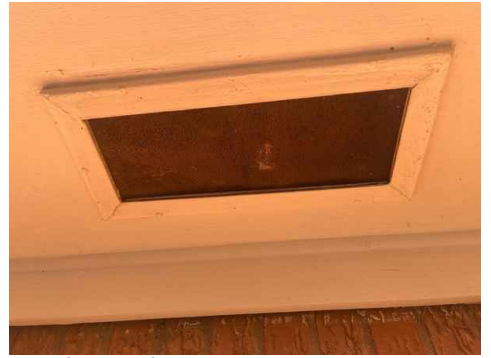
North, South, West, East

**EAVE VENTS DIRTY**

Observed eaves vents dirty. Recommend cleaning with broom or washcloth. When vents get clogged with dust dirt it limits flow of air, which is undesirable for attic conditions.
